APPLICATION OF HARDFACING LAYERS FOR RENOVATION FUNCTIONAL SURFACES OF BIOMASS CRUSHER

Abstract

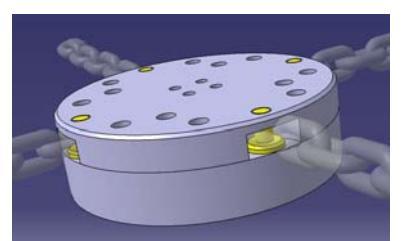
Figure 3 Top (head) of the grinder with chain's fixation [2]

Functional part of the grinder is rotating top (head), in which 4 chains are affixed by using the pegs.

Top of the previous grinder with the chain (Figure 3) has a diameter of 220 mm and is made from the material X5CrNi18-10 EN 10028-7.

Chain is made from the steel 10S20 EN 87-70, PN 46-04 grade 100. Length of the chain is 320 mm and it consists from 9 cells.

Taps of the diameter with the diameter of \emptyset 15 and the length of 35 mm which are used for clamping the chain to the top are made from the material X5CrNi18-10 EN 10028-7.

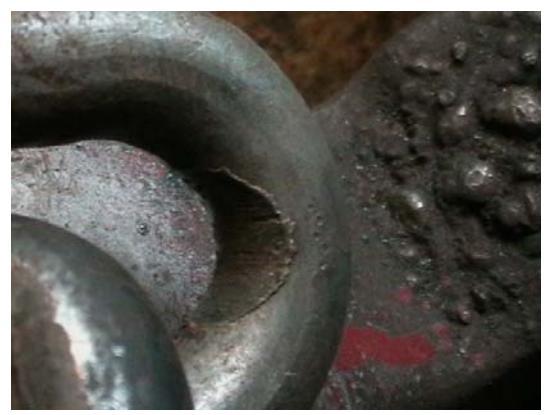
Figure 4 Detail of the worn chain eye [2]

Rapidity of the chain attrition is different. Separation of the one of the chains is not rare, what in the grinding process with high revs has destructive impact on the whole grinding cap. By attrition of the chain and the peg together length of the particular chains change (lengthening), what in the case of grinder could cause friction of the edge chain eye about the grinder inner cover, and by that its damage.

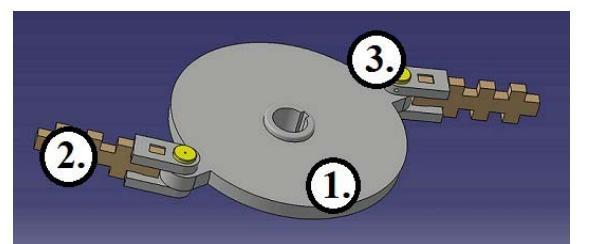
Figure 6 Innovated construction of the top of the grinder

1 - top of the grinder, 2 - crushing hammer, 3 - tap

Top of the grinder (Figure 6, number 1) has a diameter of ø 350 mm and the size 50 mm. It is made from the material X5CrNi18-10 EN 10028-7. Crushing hammers (Figure 6, number 2) are made form by welding of the burnt prepared from plasma from abrasion-resistant material Hardox 400, with the size of 15 mm, which chemical and mechanical characteristics are introduced in the Table 1 and 2. Crushing effect of the four chains is replaced by 2 hammers. Rangy shape of the crushing hammers was chosen with respect to higher efficiency of the grinding compared to the straight shape of hammer (Figure 7).

From this reason four chains were within the grinding innovation process replaced by two hammers made from abrasion-resistant material Hardox 400 (Figure 6). Besides the prevention of the grinder destruction when the chain separates one of the reason for innovation was also the possibility of renovation of the functional surfaces of the hammers by the arc hard surfacing. It is possible to multiply extend a lifetime of the hammers by the application of the hardly welding layers at the functional surfaces.

Alternative solution could be the top of the grinder at the Figure 6.

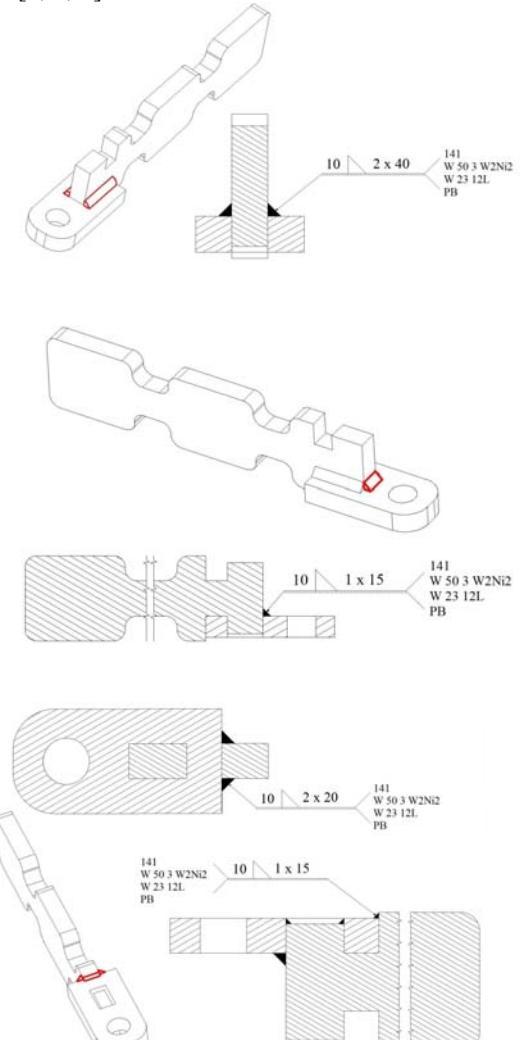
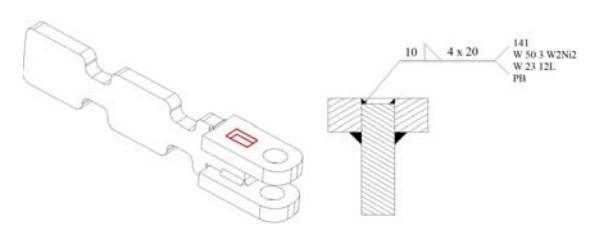
Figure 9 Process of weldment preparation [2]

Crushing hammers were made by welding using the method TIG (141 STN EN ISO 4063) in the protecting atmosphere of the mixed gas Ferroline C6X1 from the production of the company Messer Tatragas s.r.o. [4]. Weld joints were prepared in the position PB STN EN ISO 6947 at the equipment Fronius MagicWave 4000 Job according to Figure 9. [2, 5, 6]

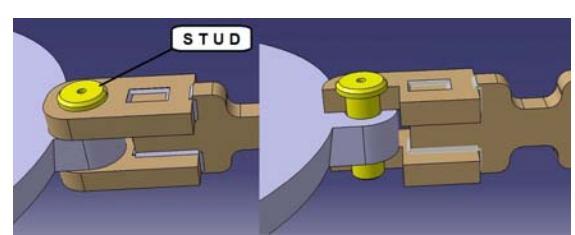
Figure 10 Demountable connection of the crushing hammers with the top of a grinder [2]

Hammers are connected to the top of a grinder by the taps (Figure 10). Taps are made from the same material as the top of a grinder, X5CrNi18-10 EN 10028-7. Tap allows steering movement of the hammers, but mostly the simple removal of the hammers in a case of their maintenance or replacement.

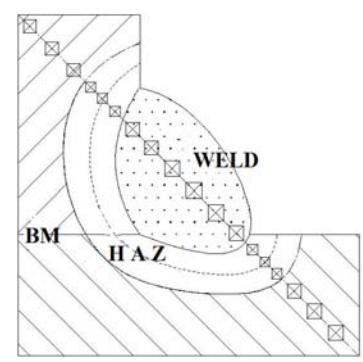
Figure 11 Diagram of the microhardness evaluation on the sections of the fillet weld joints

On the cross sections the microhardness according Vickers in terms of STN EN ISO 9015-2 was examined. Measurements were realized at the equipment Shimadzu HMV 2 according the diagram in the Figure 11. The power of 980,1 mN affect the indentor. Measured patterns have been prepared in accordance with STN EN ISO/DIS 6507-1.[9-12]

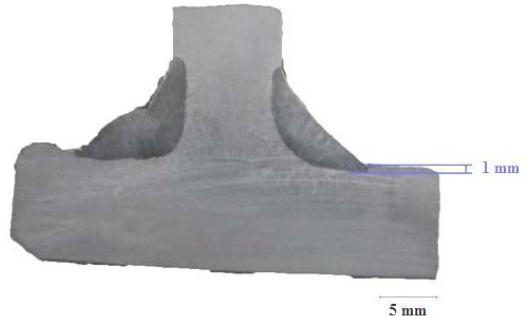
Figure 12 Macrostructure of the reversible fillet weld of the crushing hammer [2]

In the Figure 12 there is a macrostructure of reversible fillet weld. By the macroscopic control there wasn't identified the presence of the inner defects on the sections of the fillet welds. In the symmetry there were found some little deviation

but these were within the bounds of tolerance. Depth of the weld joint corresponds with the used welding parameters. For enlargement of the weld joint it is possible to recommend the welding flow increase up to 150 A in the radix and up to 180 A in the cover layer.

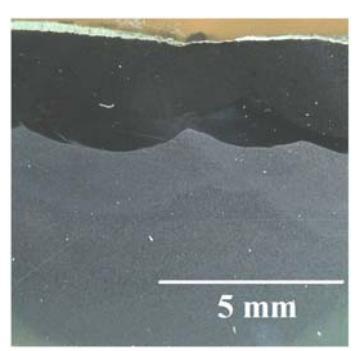
Figure 13 Macrostructure of the two-layer weld deposit

In the Figure 13 there is macrostructure of twolayer weld deposit. On the macrostructure there is obvious the height of welding layers, sketch of the base pass weld, as well as the area of the heat influence. There wasn't identified the presence of the inner defects on the examined sections.

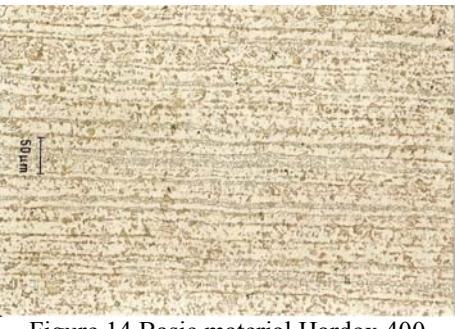
Figure 14 Basic material Hardox 400

Basic material HARDOX 400 (Figure 14) has structure formed by line fain grain ferritic-perlic matrix, inside which occurs grains of bainite and martensite.

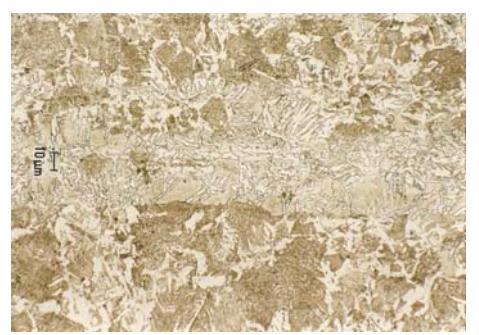
Figure 15 Detail of the martensitic structure passing the centre of the tin plate

Very interesting findings was presence of the temperable line martensitic structure which passed exactly through centre of the tin plate (Figure 15).

This line appeared probably during the termomechanical treatment of the tin plate at the point of its production.

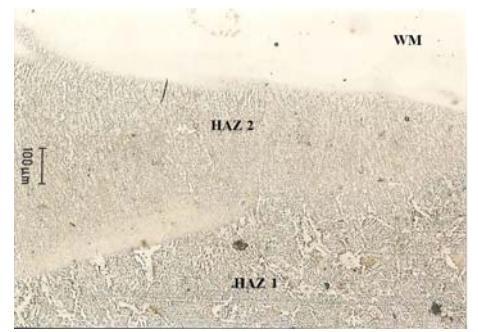
Figure 16 Microstructure of the weld metal passing to the basic material

The zone where weld metal merges into the basic material is in the Figure 16. Under the weld joint it was possible to identify two heat influenced area of the basic material.

Area marked as HAZ 2 is formed by fain grain bainite-martensitic structure with the acicular ferrite and pseudo eutectoid ferrite. Area HAZ 1 is formed by coarse-grained structure with the ferrite, perlite and martensite. Somewhere it was possible to observe Widmanstätten structure.

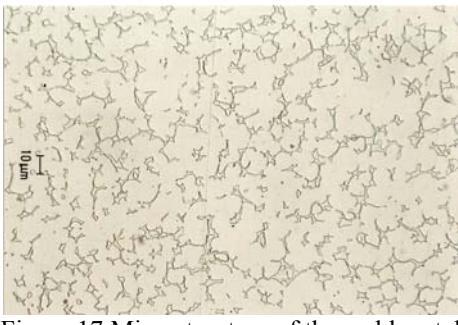
Figure 17 Microstructure of the weld metal (OK Tigrod 309L)

Weld metal of the additional material OK Tigrot 309L has a structure formed by austenite and δ -ferrite (Figure 17). Using the constitutional Schaffler diagram it is assumed content of δ -ferrite inside the weld metal in an amount of 20 %.

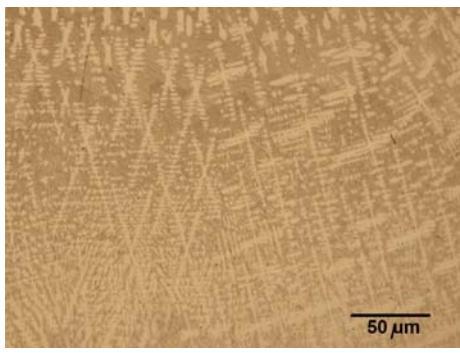
Figure 18 Microstructure of the weld metal (Lincore 60-O)

Structure of hard surfacing metal prepared by additional material Lincore 60-O is in the Figure 18. Austenitic or eutectic structure includes a big amount of primary carbides. Presented dendrite formations are oriented at the direction of weld deposit cooling.

This type of structure tends to the formation of the cod cracks.

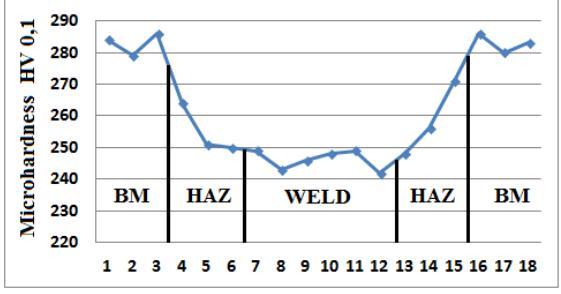
Figure 19 The curve of microhradness of the fillet weld of the crushing hammer (BM – basic material, HAZ – heat influenced area)

The results of microhardness evaluation are displayed in the graph in the Figure 19. Resulting from the curve the maximum values were measured at interval of 279 - 286 HV 0,1 I in the basic material Hardox 400. In HAZ microhardness drops down on the minimum values at interval of 242 - 249 HV 0,1 that were measured inside a weld metal made by additional material OK Tigrot 309L. The curve of measured values of microhardness matches with the chemical structure of used materials and also they are in accordance with declared values from producers.

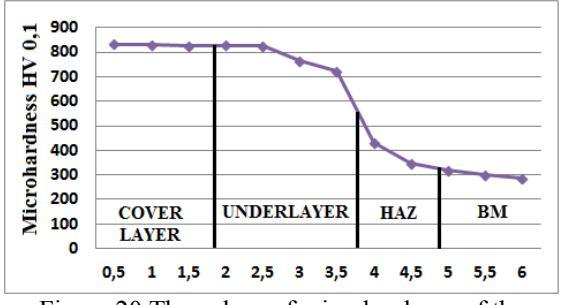
Figure 20 The values of microhardness of the samples with cladding

Measured values of hard surfacing metal microhardness are displayed in the graph in the Figure 20. Measurement was realized on the cross sections in 0,5 mm distance out of the weld deposit surface in the direction to the basic material. Twelve measurements were realized.

Maximum values of microhardness were measured on the covering weld layer, namely 832-830 HV 0,1.

On the values of the base weld layer there wasn't determined significant influence of mixing the weld metal with the basic material, what could happened because of using the small diameter of additional material (Ø 1,6 mm), which doesn't cause intensive mixing of the molten metal during the hard surfacing. In the base layer there were measured values at interval of 828-550 HV 0,1. In HAZ there were measured the microhardness from 540 to 325 HV 0,1. Minimum values from 318 to 286 HV 0,1 were measured in the basic material Hardox 400.
